**CTA Bus Slow Zone Study
Final Project Report
CTA Route #66
Chicago Avenue**

**Prepared for:
Chicago Transit Authority
Chicago Department of Transportation**

**By:
Stanley Consultants Inc.
EJM Engineering Inc.**

**Final
June 2018**

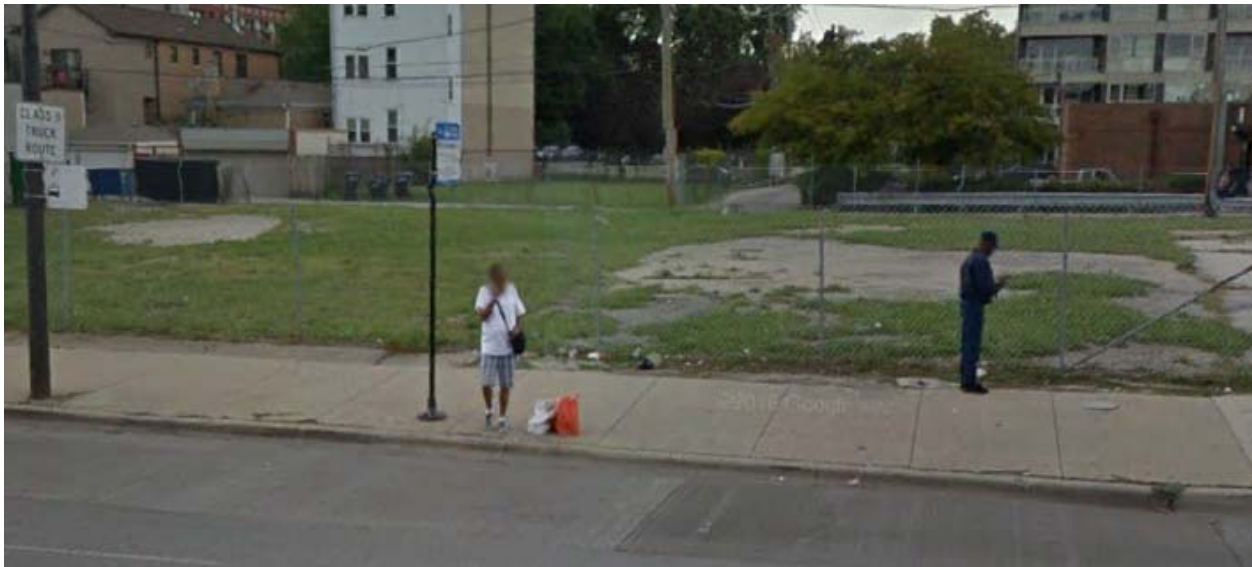
Figure 1: Northwest Corner of Chicago - Western Bus Stop

Chicago Avenue and Western Avenue are both four-lane roadways. Western Avenue has a functional classification as an Other Principal Arterial. The bus stops of concern are located on the north curb west of the intersection and at the southwest corner. The southwest corner bus stop has a shelter and a 4.5 foot wide sidewalk behind the shelter. Free parking is available on Chicago Avenue west of the intersection while pay to park is located east of Western Avenue. See exhibit C-1 for more detailed physical characteristics.

The buses are primarily affected by the congested conditions at the intersection. Significant queue lengths occurred for westbound traffic in the PM peak and for eastbound traffic in the AM peak. West of Western Avenue, the study team observed westbound buses skipping the bus stop one out of every four times due to lack of boarding or alighting passengers. The buses frequently lowered at the westbound stop to allow passengers to board causing some delays.

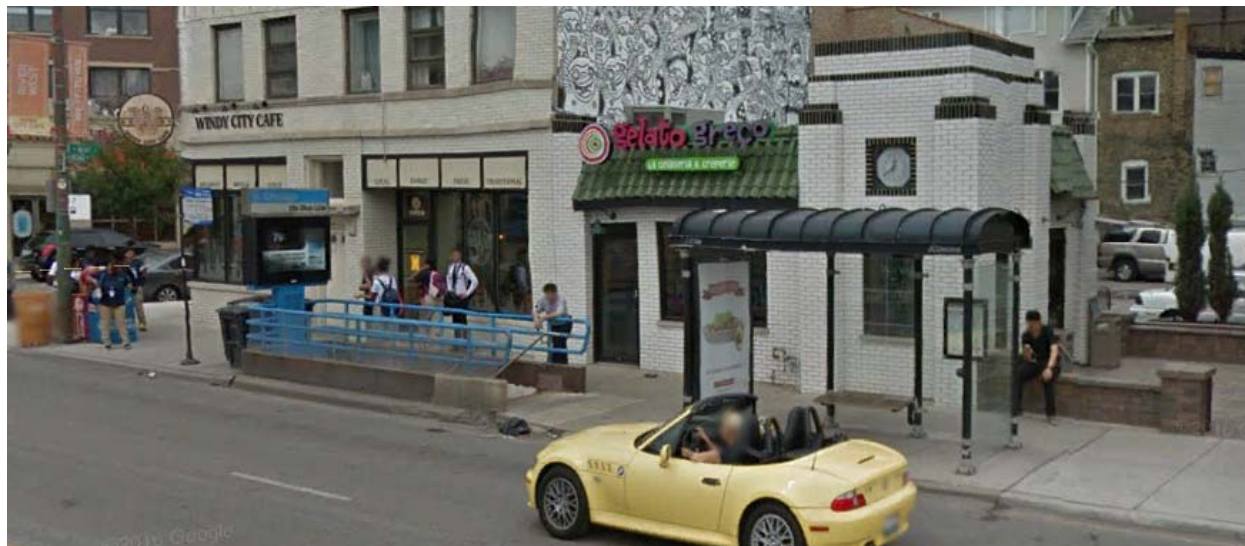
Figure 2: North Curb Bus Stop and Shelter between Milwaukee and Ogden

Chicago Avenue, Ogden Avenue and Milwaukee Avenue intersect at three closely spaced intersections that form a triangle. Ogden Avenue is a four-lane northeast-southwest roadway; Milwaukee Avenue is a two-lane northwest-southeast roadway; and Chicago Avenue is a four-lane east-west roadway. Both Ogden Avenue and Milwaukee Avenue are functionally classified as Major Collectors. The bus stops of concern are located on the southwest corner of Chicago Avenue and Milwaukee Avenue (5" curb), on the north curb of Chicago Avenue between Milwaukee Avenue and May Street (3" curb) and the southwest corner of Chicago Avenue and Carpenter Street (6" curb). The two bus stops east of Milwaukee Avenue have bus shelters. The two bus stops west of Ogden Avenue also are near stairwell entrances to the CTA Blue Line station. Pay-to-park is available on Chicago Avenue west of Milwaukee Avenue and with multiple parking restrictions east of Ogden Avenue. See exhibit C-2 for more detailed physical characteristics.

This is a complex and busy group of intersections that also has a CTA Blue Line Station. The study team observed extended loading times for CTA buses at the eastbound bus station west of Milwaukee Avenue due to two factors: passengers experienced difficulties maneuvering around and exiting the nearby Blue Line Station stairwell; and CTA buses were observed bunching together west of May Street and loading and alighting passengers near the fire station.

For the CTA buses at the westbound bus station between May Street and Ogden Avenue, there were large volumes of boarding passengers, and similar to the eastbound bus stop, the study team observed the passengers having difficulties maneuvering around and exiting the nearby Blue Line Station stairwell as well. The westbound bus stop often received two buses simultaneously. Buses were frequently too full to accommodate everyone that was waiting at westbound stop between Milwaukee Avenue and Ogden Avenue.

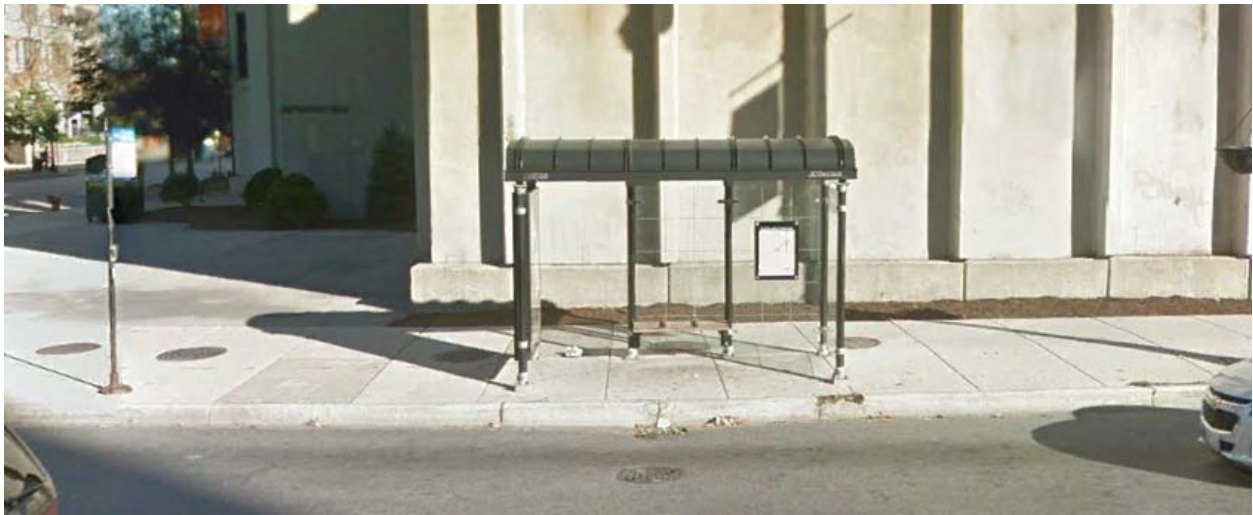
Larrabee Street is a two-way street north of Chicago Avenue and one-way northbound south of the intersection. Larrabee Street is functionally classified as a Major Collector north of the intersection and a local street south of Chicago Avenue. The bus stops are located near-side for westbound traffic and far-side for eastbound traffic. Both bus stops have shelters. The eastbound bus stop has a 5-foot wide sidewalk behind the shelter. Parking is not allowed west of the intersection but pay to park is available east of Larrabee Street on both sides of the street. The east leg has a significantly long diagonal crosswalk due to the offset of the intersection. The offset south approach creates safety concern. See exhibit C-3 for more detailed physical characteristics.

Figure 3: Northeast Corner of Chicago - Larrabee Bus Stop and Shelter

Extremely long queues for eastbound traffic at Larrabee Street consistently backed up onto the Chicago River Bridge and caused delays for CTA buses. There was often not enough green arrow time for the eastbound to northbound left turn movement. Buses were observed bunching and frequently lowering the bus for all passengers.

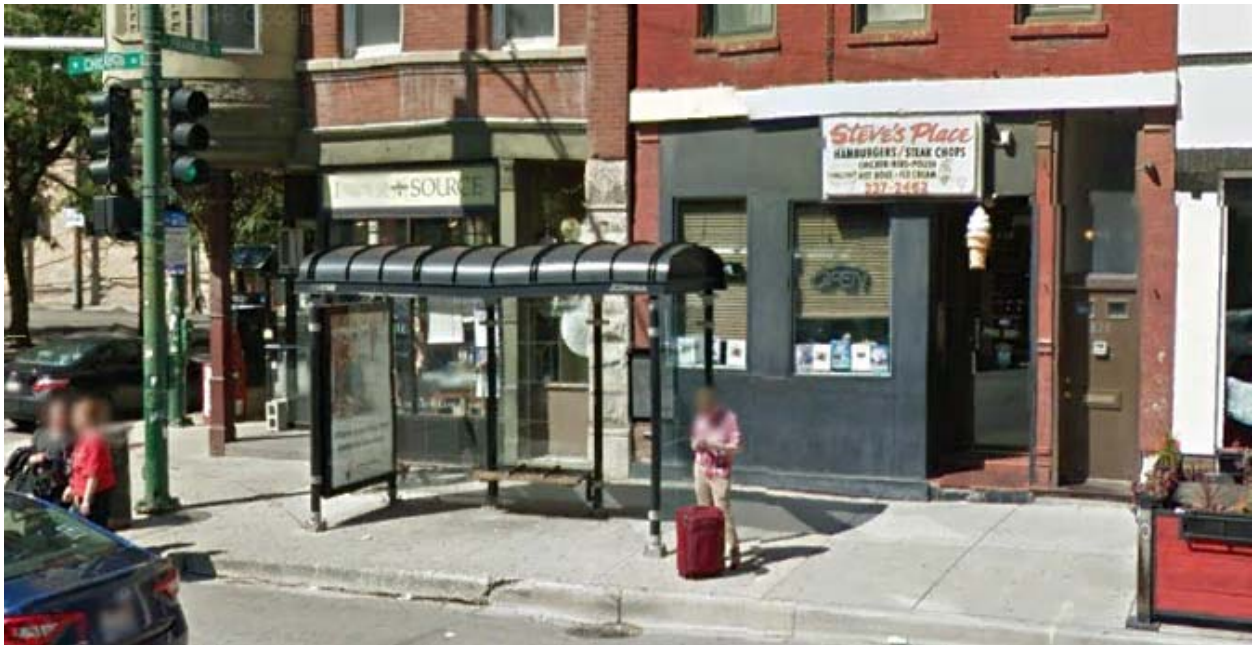
Figure 4: Northeast Corner of Chicago - Franklin Bus Stop and Shelter

Franklin Street is a two-lane roadway and has the CTA Brown Line travel above it south of Chicago Avenue. The intersection has curb bump outs for the northwest and southwest corners due to the CTA Brown Line columns. Entrances to the Brown Line are located east and west of the intersection on the south curb. Franklin Street is functionally classified as a local roadway. The bus stops being reviewed are located near-side for both eastbound and westbound directions. The westbound near-side bus stop has a shelter. Chicago Avenue has various pay-to-park and loading zones on both curbs on either side of Franklin Street. See exhibit C-4 for more detailed physical characteristics.

The study team observed frequent eastbound and westbound bus bunching at Franklin Street. Non-CTA vehicles using the loading zone near the southwest corner of Franklin Street were observed hindering CTA buses trying to enter traffic from the bus stop west of the loading zone. Pedestrians were observed crossing Chicago Avenue between Franklin Street and Orleans Street and caused delays for traffic. All queue lengths were larger during the PM peak between Franklin Street and LaSalle Street.

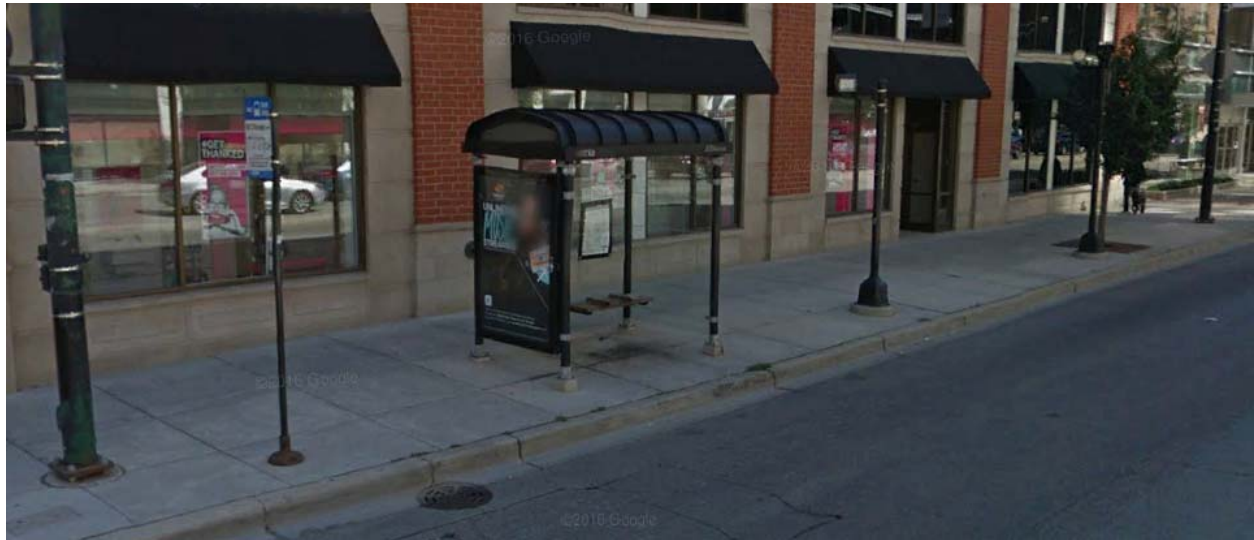
Figure 6: Northeast Corner of Chicago - Clark Bus Stop and Shelter

Clark Street and Dearborn Street are both three-lane one-way roadways forming a one-way pair. Both roadways are functionally classified as Major Collectors. Clark Street has southbound traffic and Dearborn Street has northbound traffic. The Clark Street bus stops are located near-side for both eastbound and westbound traffic, and both bus stops have shelters. The Dearborn Street has a shelter on the northeast corner but the bus stop is no longer in use. There is a combination of pay-to-park and no parking zones on both curbs between Clark Street and Dearborn Street. See exhibit C-6 for more detailed physical characteristics.

Large queue lengths were observed for westbound traffic at Clark Street during the PM peak. Very little passenger vehicle movement other than thru traffic was observed on Chicago Avenue between LaSalle Street and Dearborn Street. See exhibits D-12 and D-13 for more detailed travel characteristics.

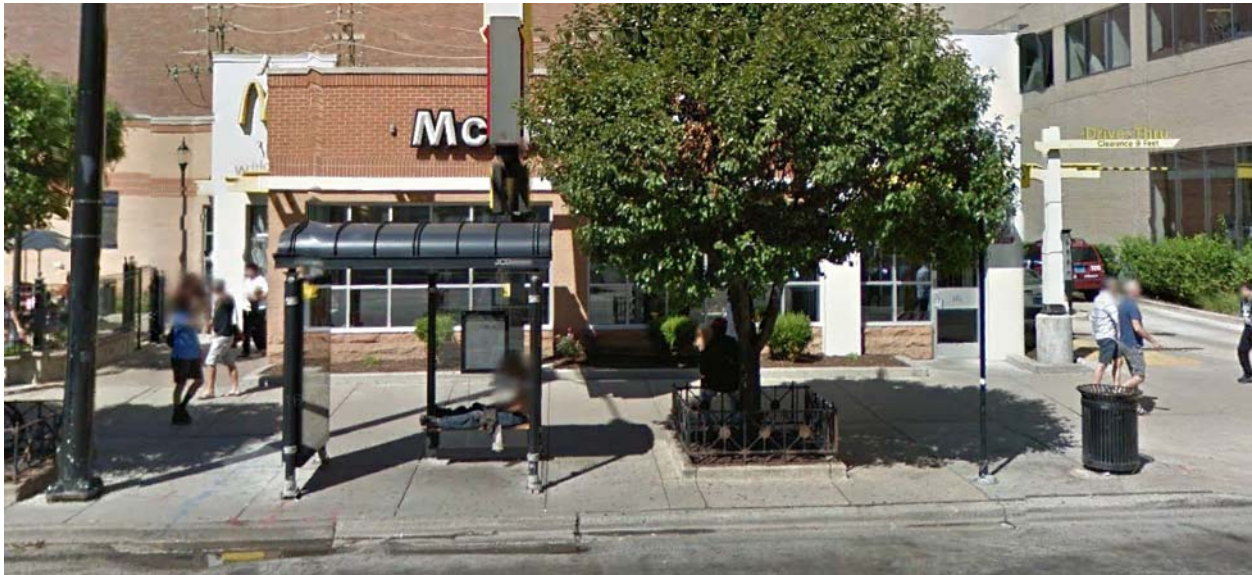
Figure 7: Northeast Corner of Chicago - State Bus Stop and Shelter

State Street is a two-lane roadway and is functionally classified as a Major Collector. The bus stops are both east of the intersection and are near stairwells for the CTA Red Line subway station. The north curb bus stop includes a shelter. There is also a bus shelter on the southeast corner but the bus stop is no longer in use. There is a combination of pay-to-park and no parking zones between Dearborn Street and Wabash Avenue on Chicago Avenue. See exhibit C-7 for more detailed physical characteristics.

At State Street, the westbound queue lengths filled the entire block on Chicago Avenue for both peak periods. Despite parking restrictions, several McDonald's customers and delivery trucks used the westbound curbside lane near State Street. These vehicles often impeded westbound CTA buses. The study team also observed westbound CTA buses between Dearborn Street and Wabash Avenue experience bunching as multiple buses would arrive simultaneously. Chicago Police Department vehicles were observed parking in eastbound and westbound curbside lanes between Dearborn Street and Wabash Avenue, causing CTA bus delays. See exhibits D-14 and D-15 for more detailed travel characteristics.

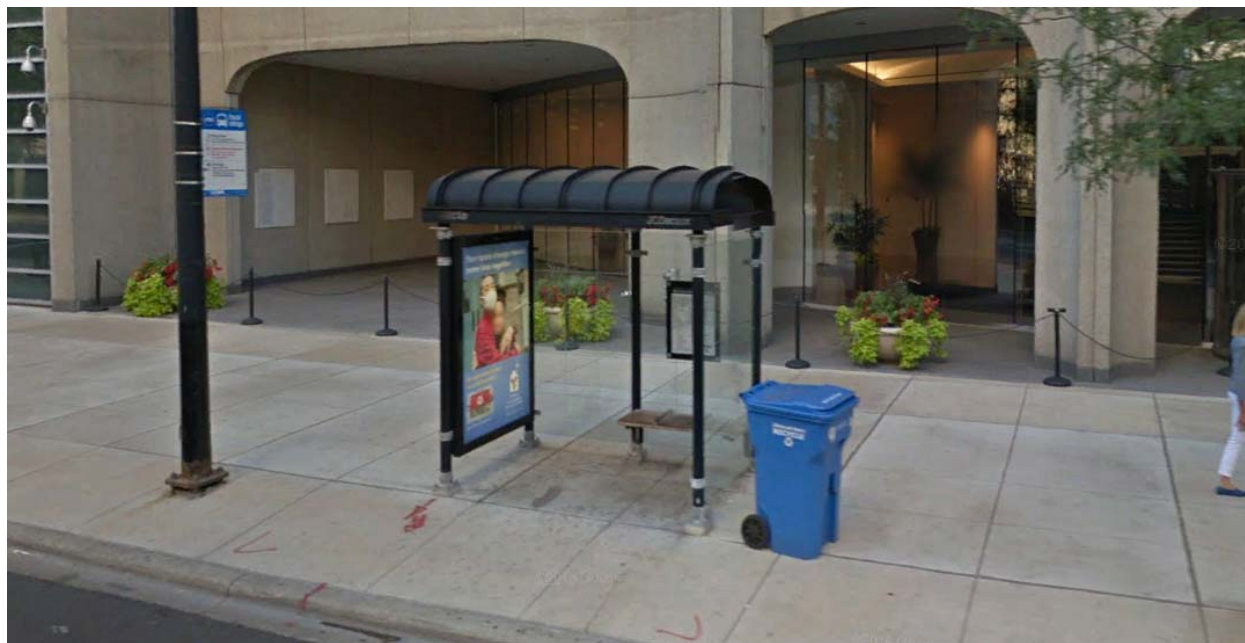
Figure 9: Southwest Corner of Chicago - Mies Van Der Rohe Bus Stop and Shelter

Mies Van Der Rohe Way is a two-way local road and forms the north leg of a T-intersection with Chicago Avenue. The bus stops are located on the northeast corner and west of the intersection on the south curb. Both bus stops include a bus shelter. Similarly, Fairbanks Court is a two-way Major Collector and forms the south leg of a T-intersection with Chicago Avenue. The Fairbanks Court bus stop is located on the southwest corner and includes a shelter as well. No parking is allowed on either curb of Chicago Avenue between Mies Van Der Rohe Way and Fairbanks Court.

The study team observed frequent drop-offs and pick-ups at the Consulate parking area and in front of the American Dental Association building on the south curb of Chicago Avenue between Michigan Avenue and Mies Van Der Rohe Way. However, these irregular movements did not appear to slow down eastbound bus traffic on Chicago Avenue. See exhibit D-18 for more detailed travel characteristics.

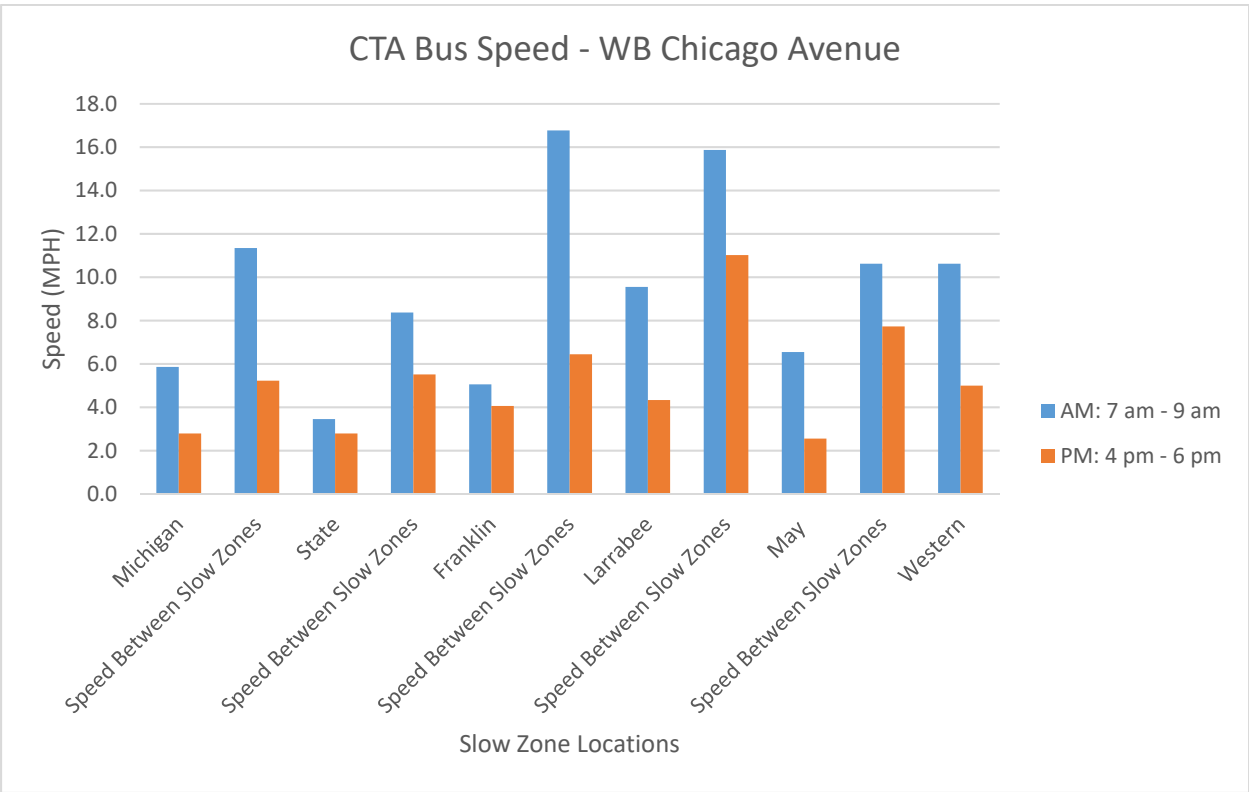
Figure 11: Westbound Chicago Avenue Bus Speed

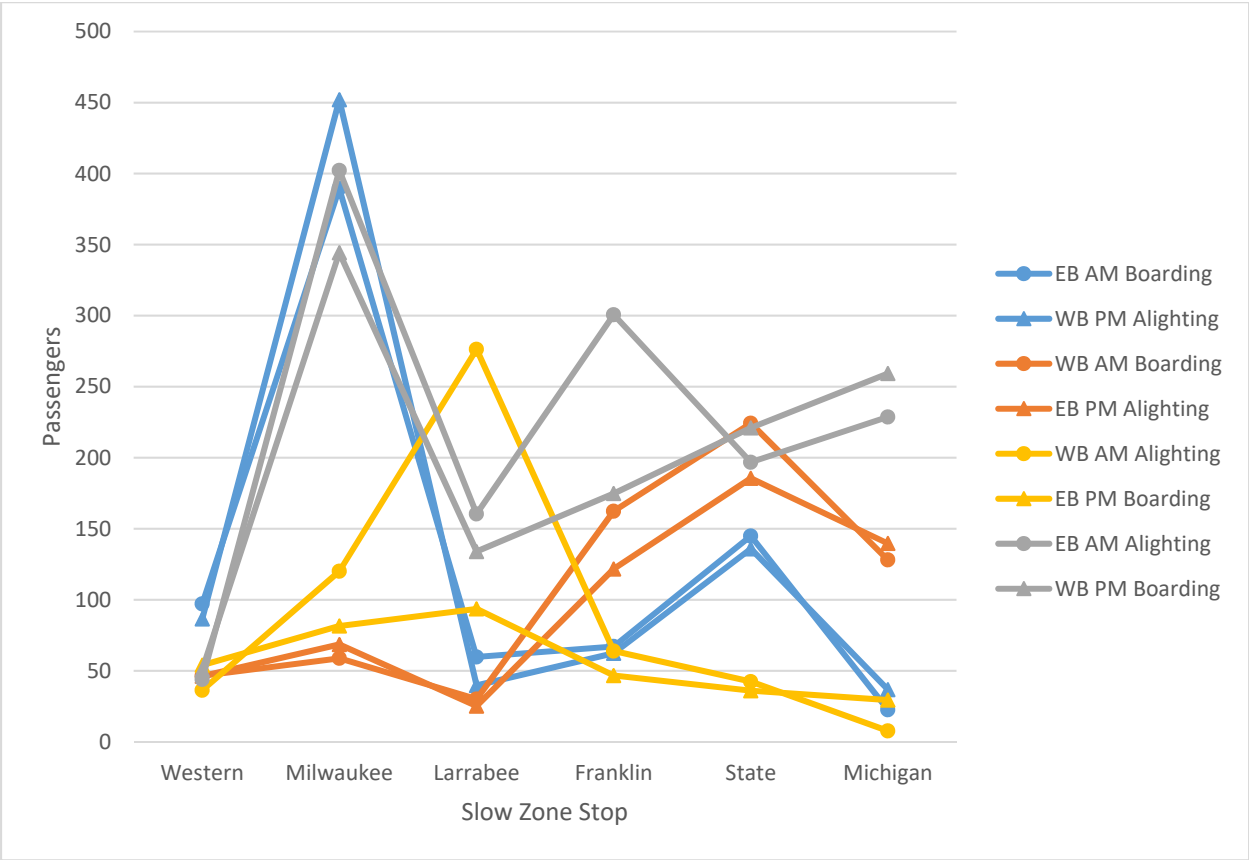
Figure 12: Chicago Avenue Boarding and Alighting

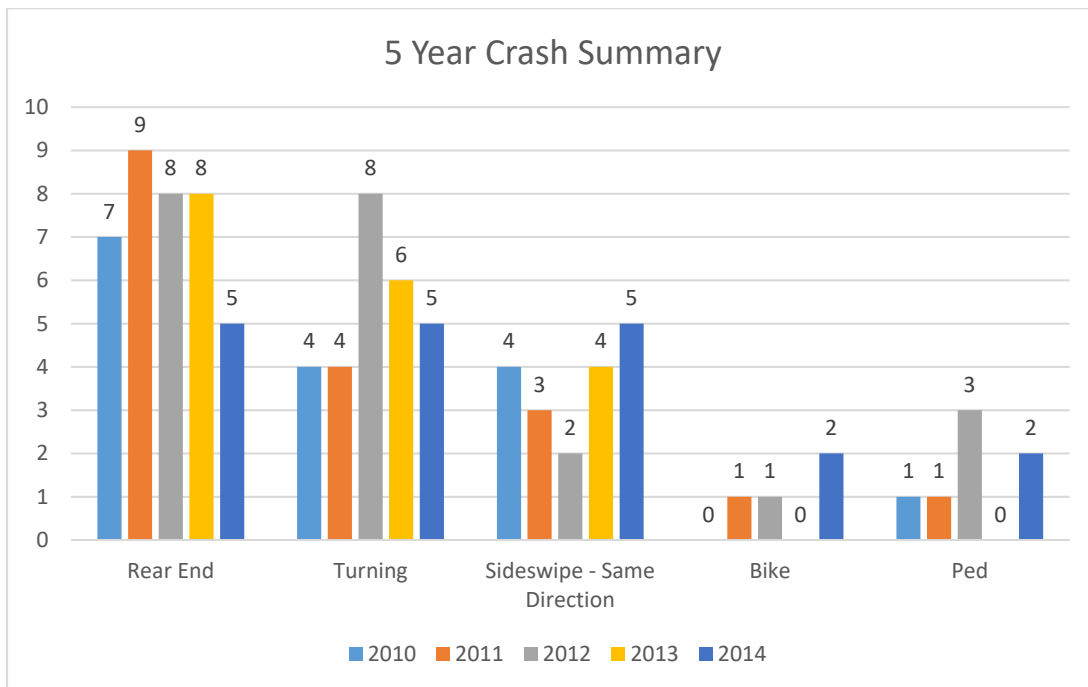
During the five-year analysis period, a total of 119 crashes occurred at the intersection of Chicago Avenue and Western Avenue. Figure 14 below shows the number crashes for the three most common crash types and bike and pedestrian crashes for each of the five years.

Figure 14: Crash Type Summary for Western Avenue

The most prevalent crash types were Rear-End, Turning, and Sideswipe – Same Direction, which accounted for 31 percent, 23 percent, and 15 percent of the total crashes reported, respectively. Of these 119 crashes, 15 collisions involved injuries of Type B or Type C severity. There were 4 crashes resulting in Type A injury and no crashes resulting in a fatality.

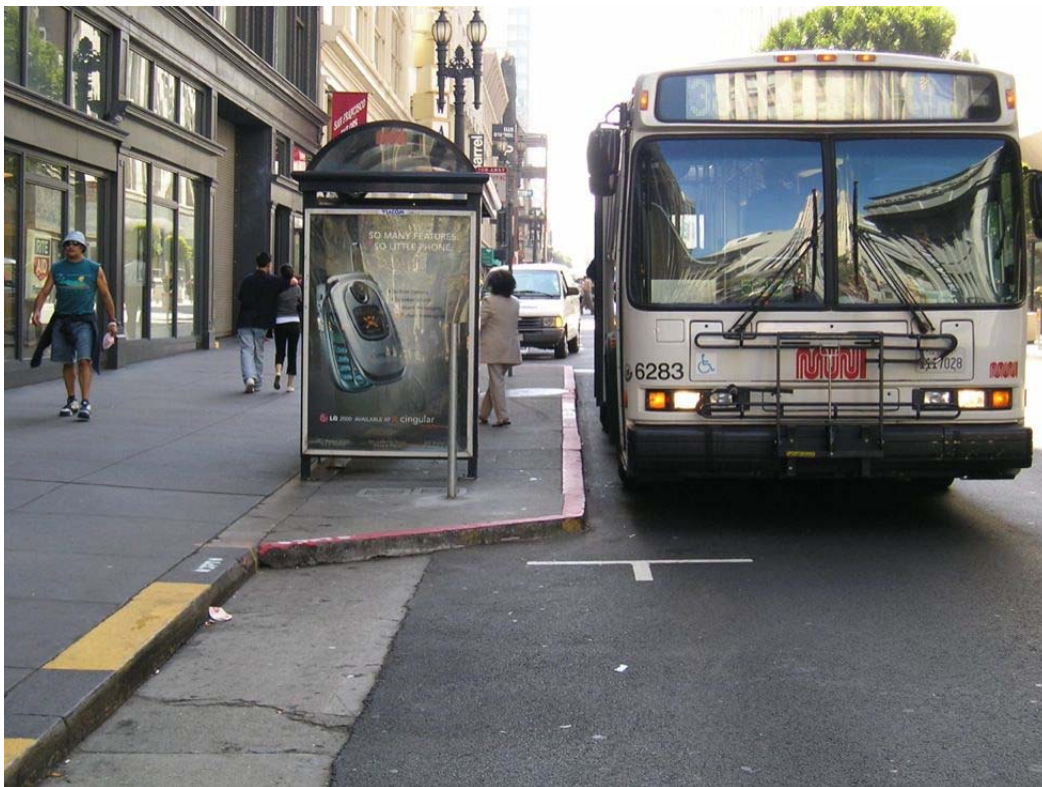
Bus bays or pull outs provide for the bus to pull out of the travel lane and into a dedicated bus loading zone to board and alight passengers without blocking traffic. In congested areas and during peak travel periods, buses often have trouble reentering the travel lane adding delay to bus travel time.

Figure 18: Example of a Bus Bump Out

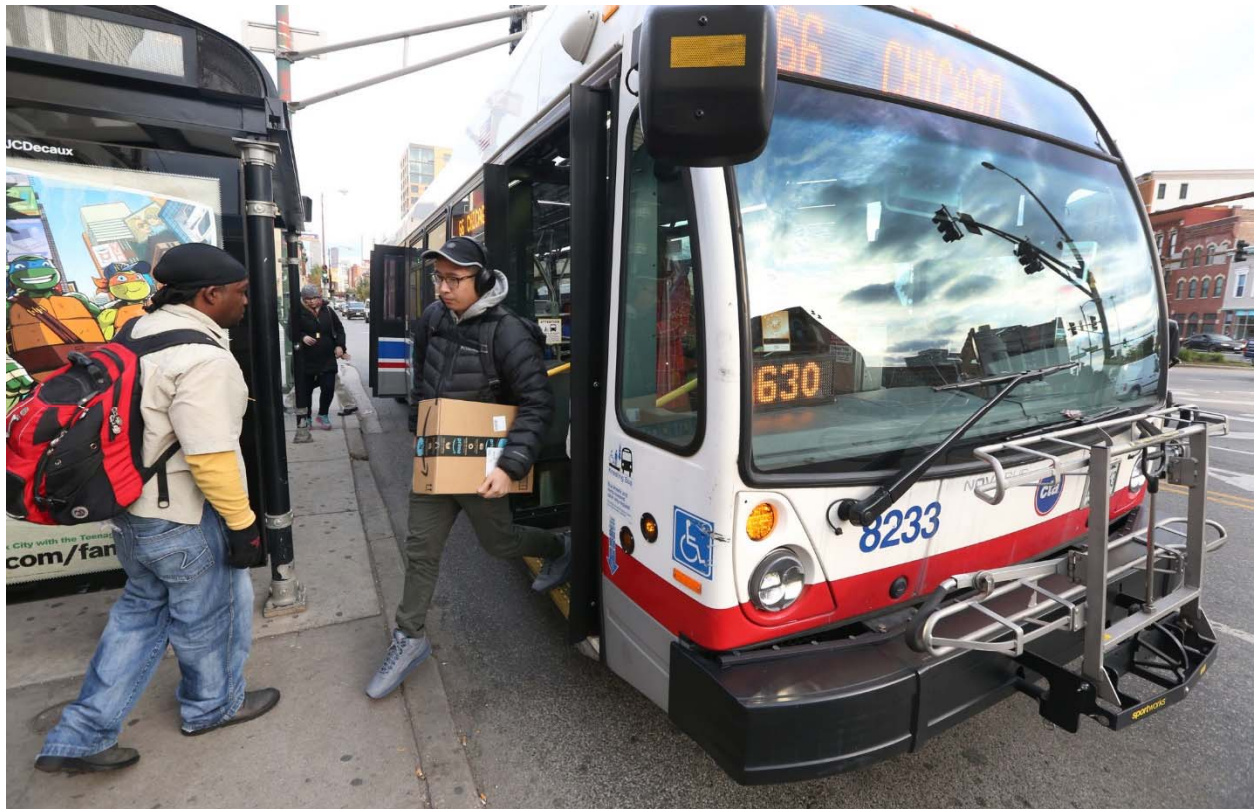
Providing level or near-level boarding is not possible at all locations because of multiple doorways, physical constraints and other impacts associated with raising a curb height 4-6 inches for the length of the bus stop. CTA prefers a minimum 100-foot area for a bus to stop to accommodate articulated buses. Raising the curb height can have impacts on Americans with Disabilities Act (ADA) and Public Right of Way Access Guide (PROWAG) compliance for sidewalks in public right of ways. Water flow and drainage could also be impacted and design of level boarding must prevent water from ponding in the sidewalk or backflowing into buildings. Narrow sidewalks with driveway and business front access pose implementation challenges. Raised curbs should be avoided where there is adjacent street parking because of conflicts with the passenger car door levels and potential vehicle damage. Examples of boarding types are shown in Figure 2 and Figure 3.

Figure 19: Example of Non-Near-Level Boarding

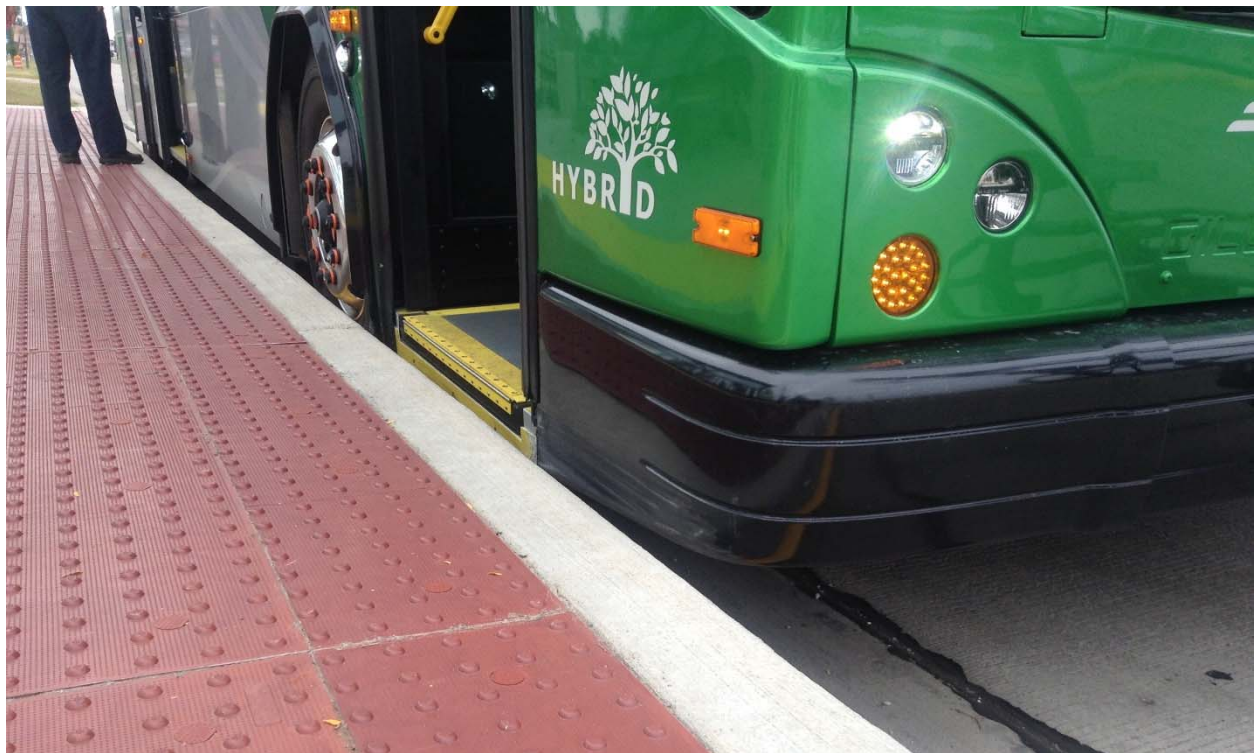
Figure 20: Example of Near-Level Boarding

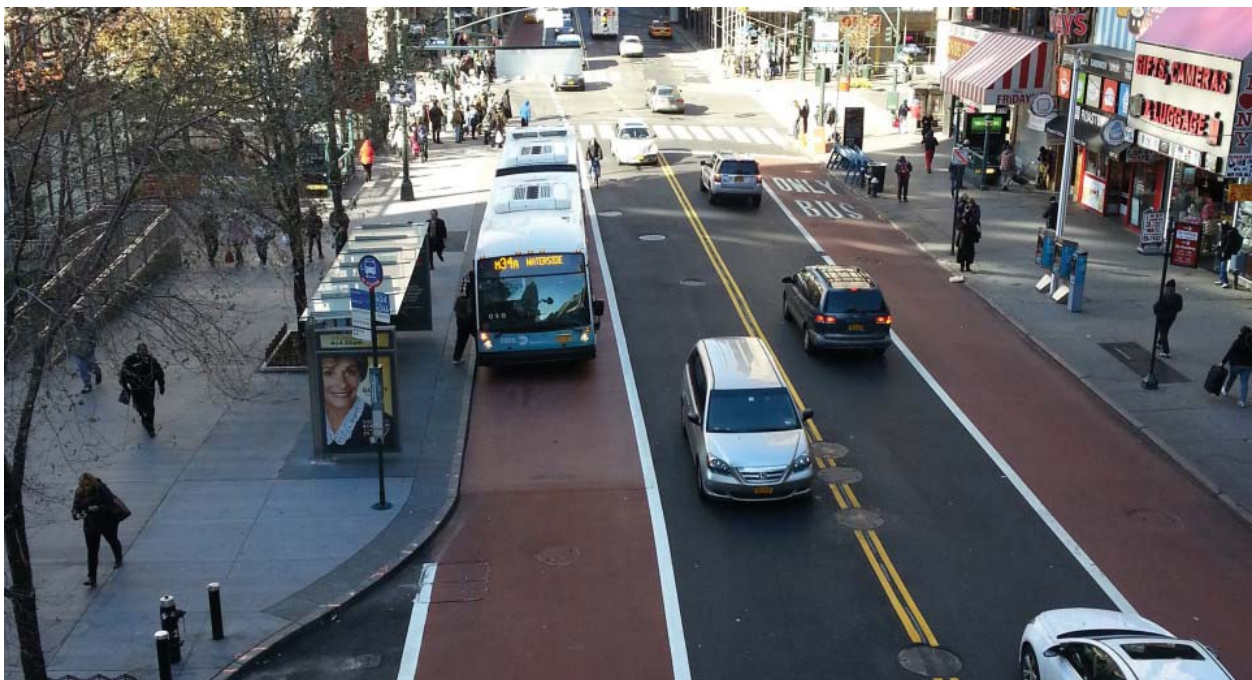
A dedicated curbside bus lane is a transit-only facility in the right-most travel lane on a street, as shown in Figure 4. There are several different configurations of dedicated bus lanes, for example, bus lanes can be in the median or in offset configurations where the dedicated bus lane runs adjacent to parking, a right turn lane, a bike lane or any combination in the outermost portion of the right-of-way. Bus lanes can also operate as a dedicated bus lane at peak travel periods, with appropriate signing and enforcement, and provide for general curbside uses, such as parking permitting mixed traffic, at other times. Figure 5 is an example of a peak hour bus facility sign used by the LA Metro.

Dedicated bus lanes are typically a minimum width of 11-feet, although, a 12-foot lane is generally preferred, the width can be as low as 10-feet in certain circumstances.

Figure 21: Example of a Dedicated Bus Lanes

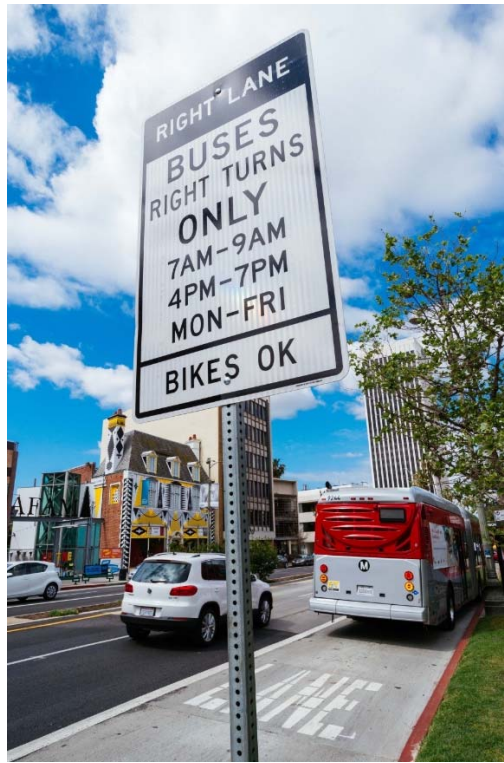
Figure 22: Example of a Peak-Hour Bus Lane

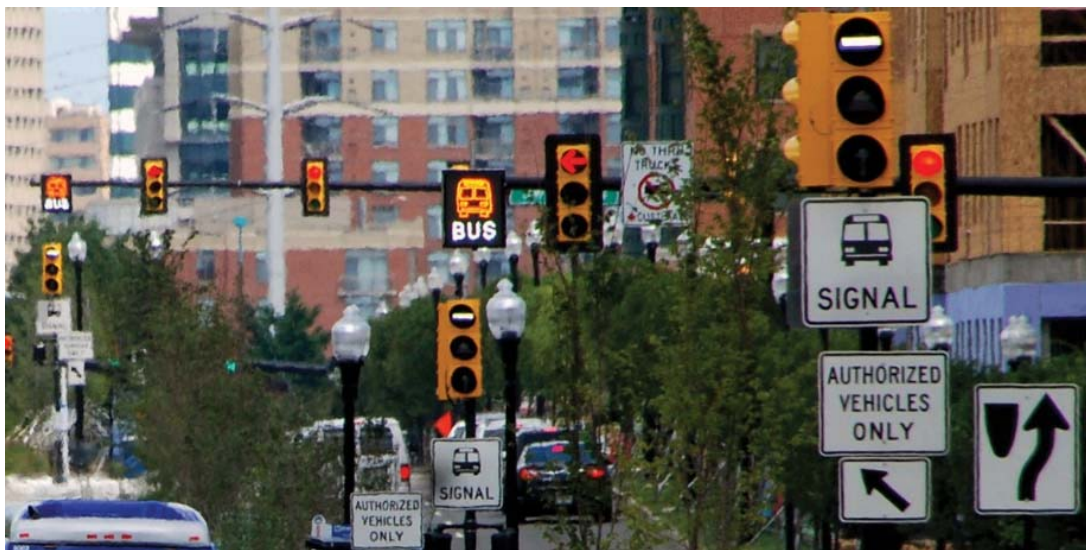
Figure 24: Example of Bus Priority Signal and Signage
